Rehabilitation of Wilson Bruce Evans Home

Phase I Porch Reconstruction and Masonry Repair

**REHABILITATION OF
WILSON BRUCE EVANS HOUSE**
 PHASE I PORCH RECONSTRUCTION AND MASONRY REPAIR
 33 E. VINE STREET OBERLIN, OHIO 44074

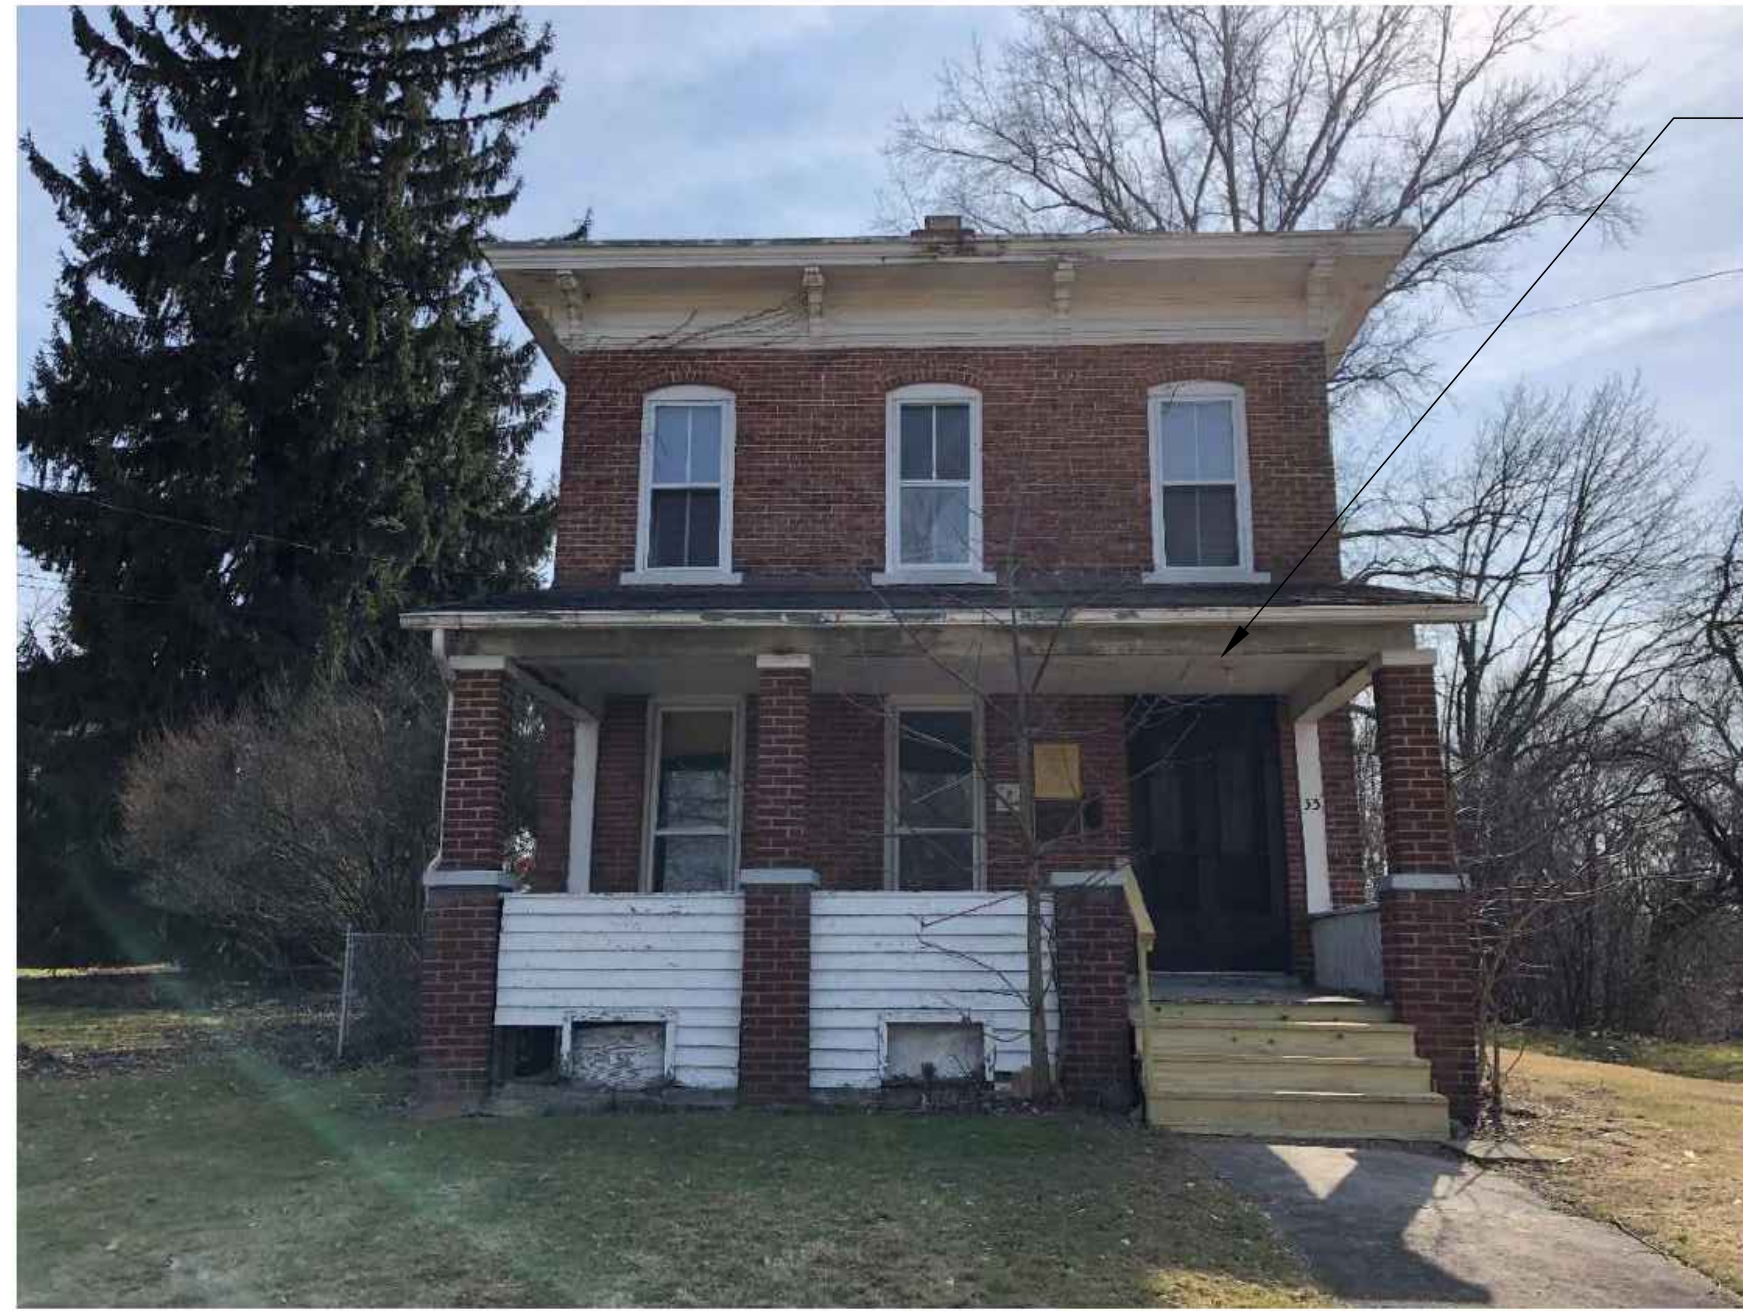
FRONT VIEW PHOTO

EXISTING PORCH TO BE DEMOLISHED IN ITS ENTIRETY, INCLUDING BRICK PIERS AND FOUNDATION. PREPARE FOR NEW CONSTRUCTION.
